# Manhole Inspection Summary

Manhole # S25I\_\_030MH

Insp Date: **3/13/08 12:55 PM**

**Location** Address: **Alley btwn 1205 & 1209 Hollins Street** Cross Street: **Hollins St**

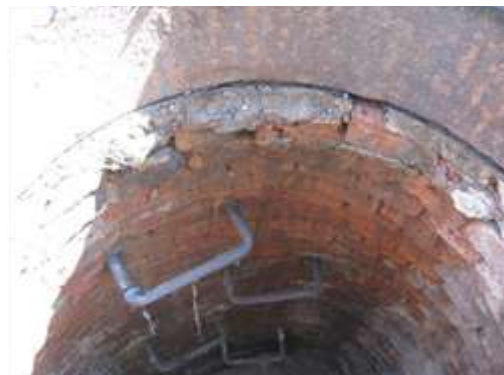
Defect 3

Condition: ☐ Sound ☐ Cracked ☐ Root Intrusion ☒ **Loose Brick** ☐ Deteriorated

Infiltration: ☐ None ☐ Joint ☐ Cracks ☐ Mortar ☐ Roots ☒ **Wall**

infiltration on barrel/loose bricks on chimney

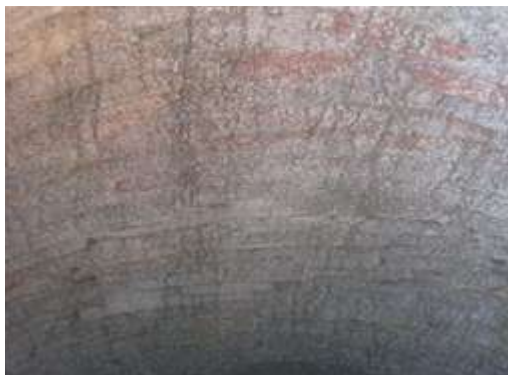
Defect 1

Infiltration: ☐ None ☐ Joint ☐ Cracks ☐ Mortar ☐ Roots ☒ **Wall**

barrel infiltration

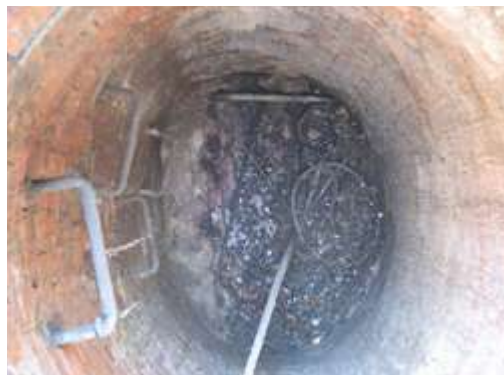
Defect 2

Condition: ☐ Sound ☐ Cracked ☐ Root Intrusion ☐ Deteriorated ☐ Leaks ☒ **Debris**

heavy channel debris

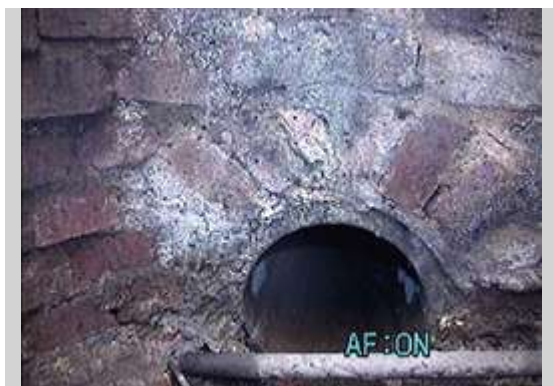
12 O'Clock Outflow

8 in. Circular Gravity Sewer  
Pipe Out @ 12 O'Clock

Infiltration: **None** Pipe Seal Cond: **Sound**
